## FFO INCIDENTS RISK PREVENTION ADVISORY LETTER

### **Trelleborg fenders arrangement on berths in the port of Novorossiysk**

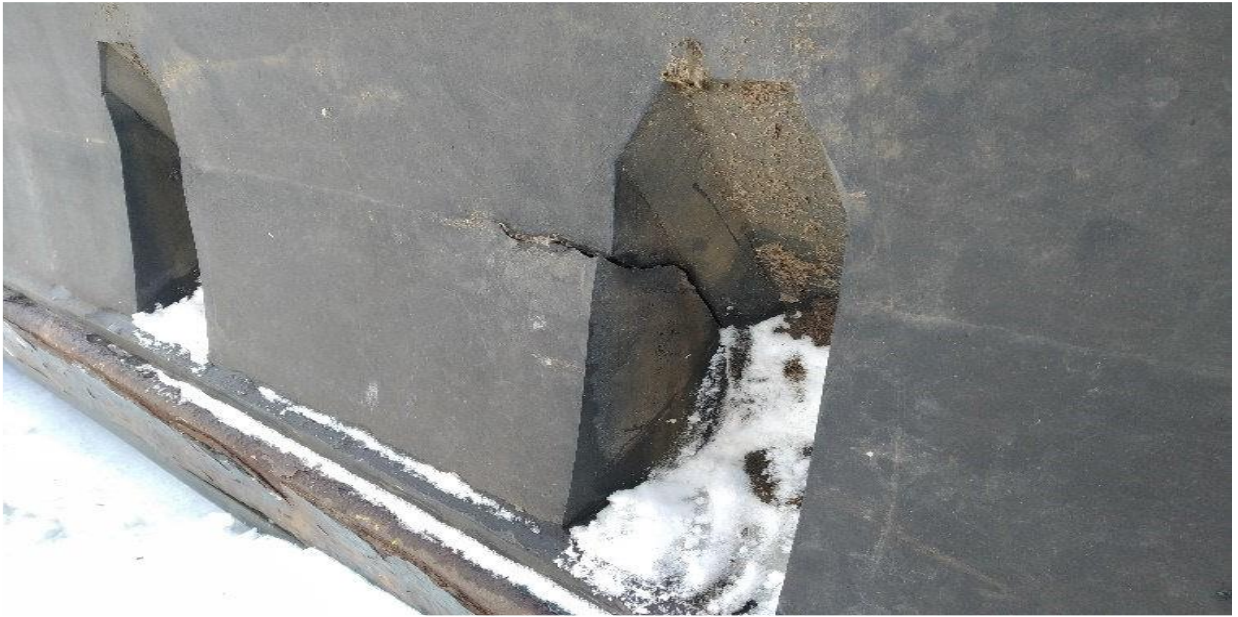
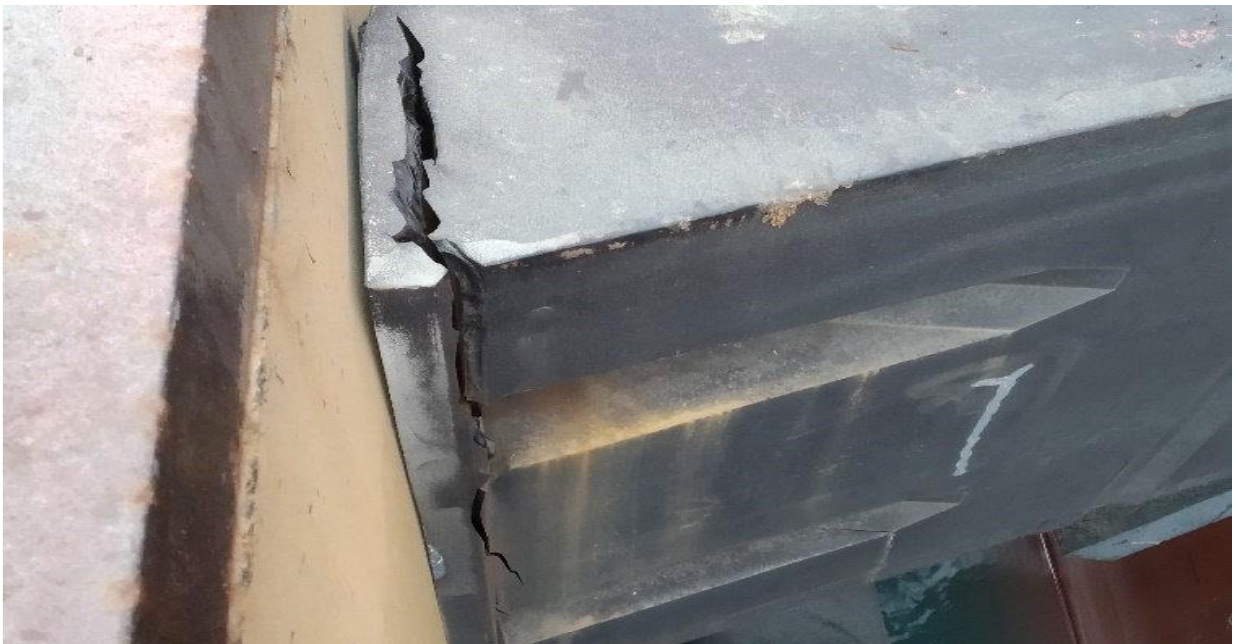
mooring lines without giving an order to the tugs to stop pushing the vessel towards the berth. Such adjustments against the arms position creates breaking loads in the shock absorbing elements of the fender, which certainly leads to the damages of the fenders as a result. Therefore, it is strongly recommended to keep the vessel's hull off the contact with fenders till the vessel is finally adjusted alongside.

Cracks on the shock absorbing elements of the fender

Another important factor while approaching to the berth equipped with MV constructed fenders is the approaching angle. By the reason described above, the approaching should be made as much parallel to the berth line as it's possible and safety practicable. Once the vessel is finally moored, it is recommended to visually inspect the condition of all the fenders which the vessel was in contact with during berthing and take photos of places of hull where contact between the hull and fender shields was observed. If possible, the officers on the mooring stations must take note of such contact recording the place (frame) and time. If the crew is not allowed to step down on the terminal or take the photos for some reasons, the postmooring condition of fenders should be assessed at least from the main deck of the vessel.

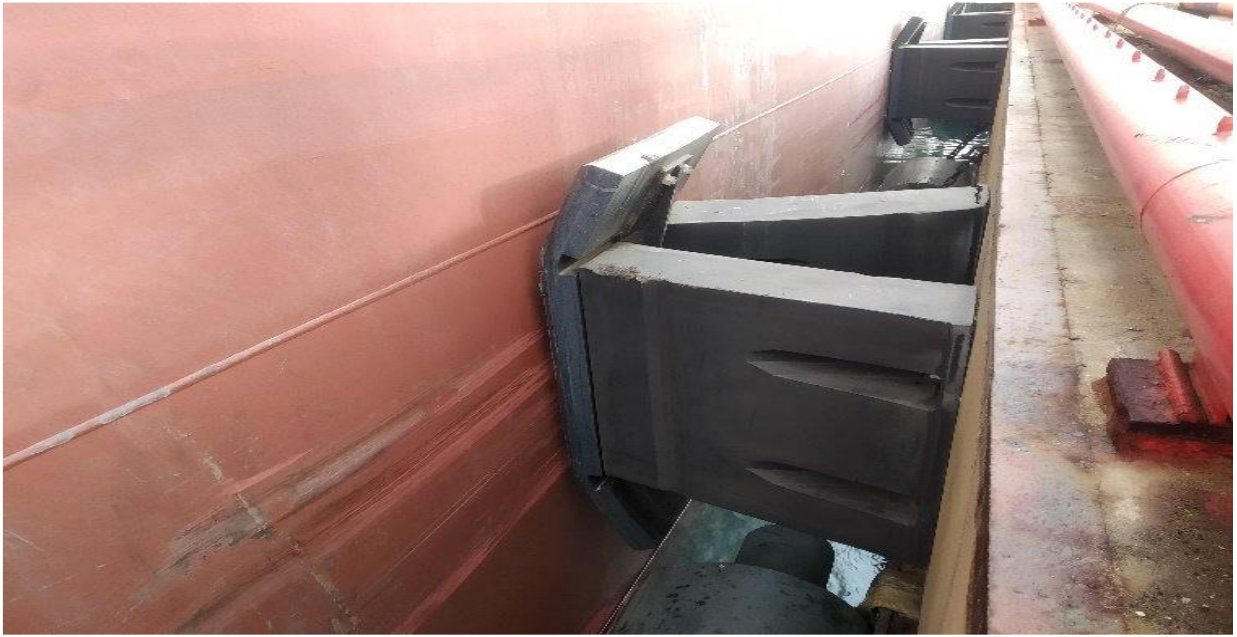
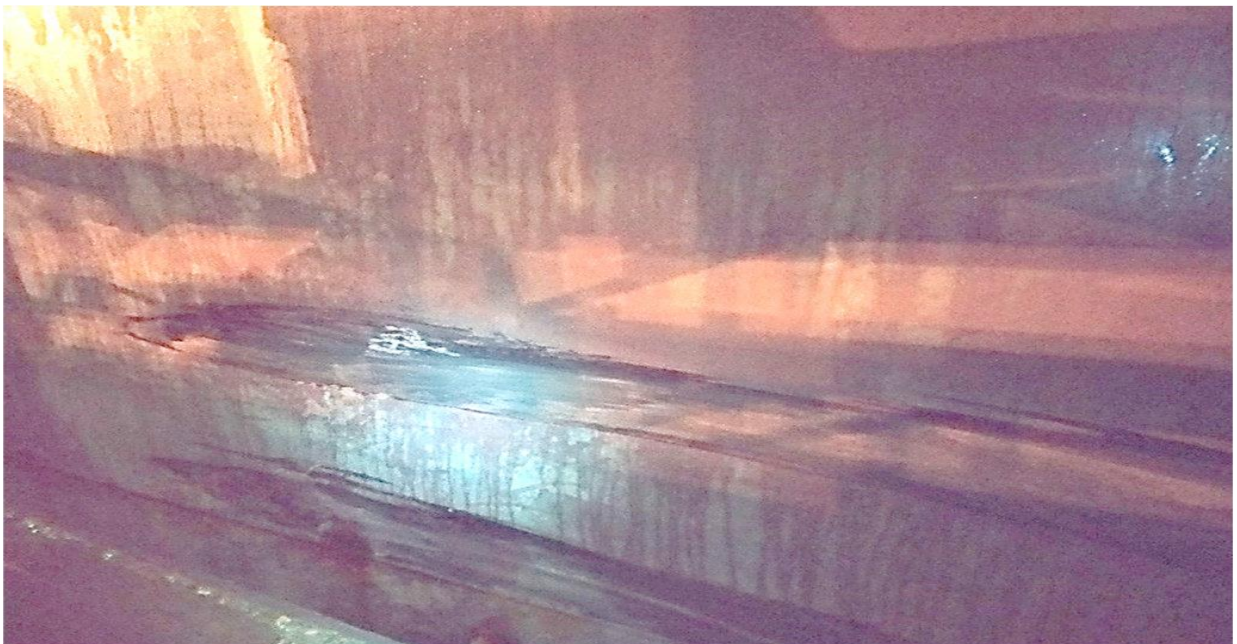
## Rubber traces and scratches on the vessel's hull

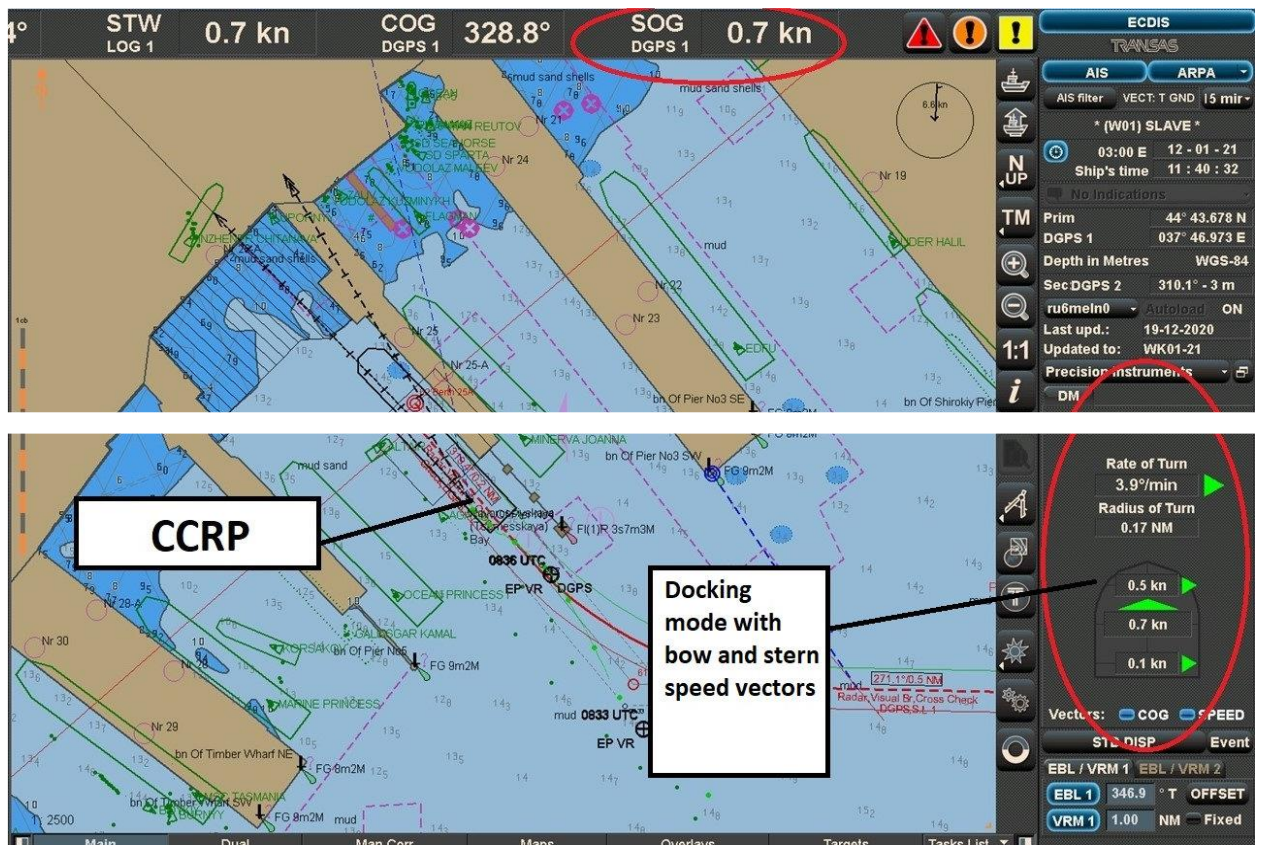
## Transas ECDIS screenshot during approaching maneuver.

As illustrated above, the ECDIS is capable to provide the operator with three speed vectors and this can be useful in the situations when the vessel is almost stopped and pushed by tugs only. While the SOG is nearly zero, the bow speed can be excessive if the tugs push the vessel extensively and produce rotation movement around CCRP.

It's worth to mention that in order to have precise vessel's motion parameters the ECDIS needs to be set up correctly and data (vessel's length, breadth, antennas' position etc.)

must match the real numbers. This can be rechecked and corrected manually by the operator depending on the ECDIS maker.
